**SURVEY REPORT**  
**FAIRYLAND POND INVENTORY AND**  
**MANAGEMENT PLAN – CONCORD, MA**

**November 2004**

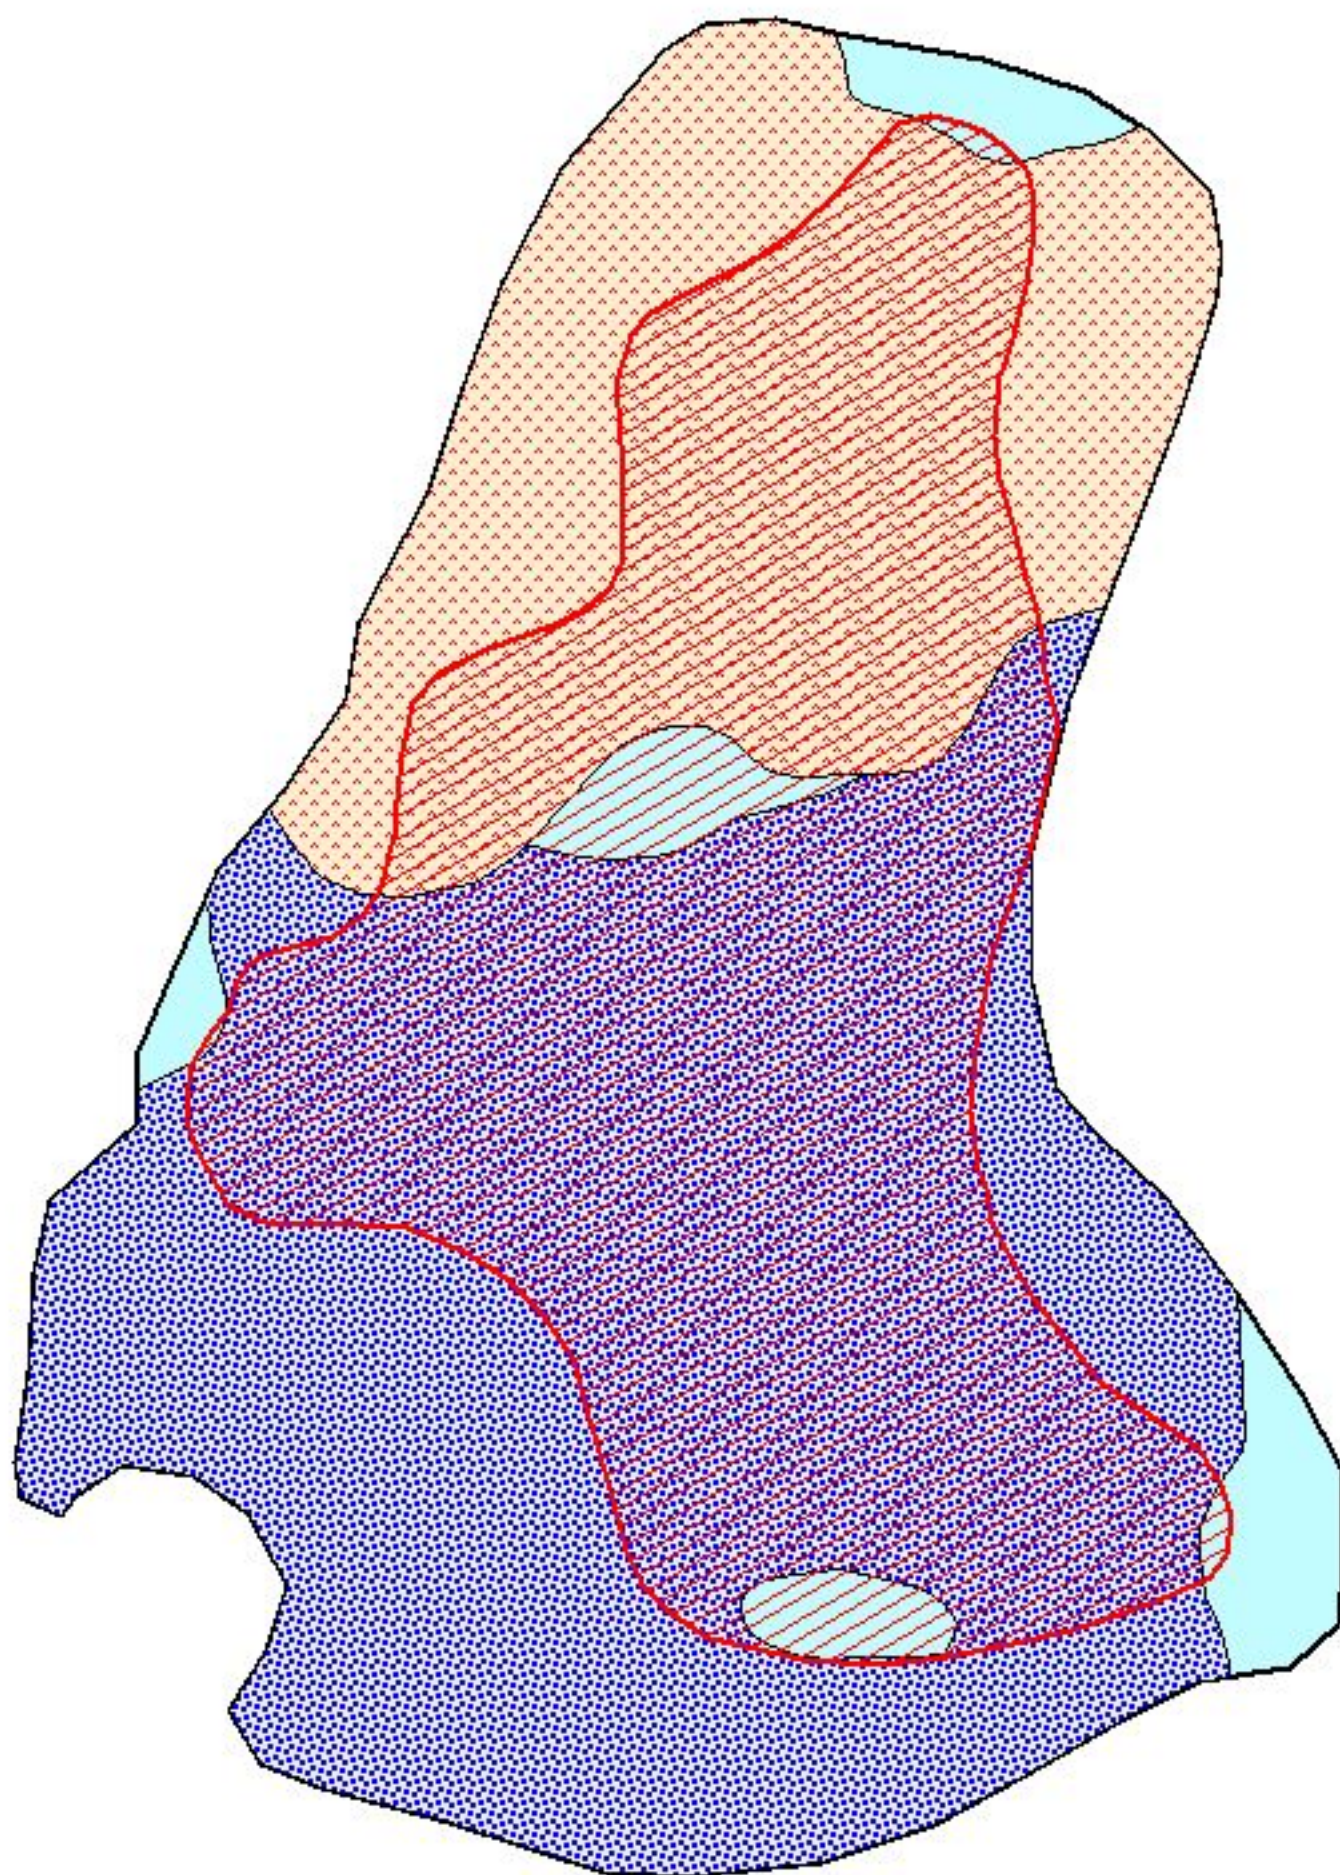
### FIGURE 6 Recommended Hydro-Raking Areas

Recommended Hydro-Raking area to restore open water and enhance fish and wildlife habitat - approximately 1.45 acres.
-

It is our opinion that suitable shoreline access for machine launching and spoils stockpiling can be achieved via the existing access path/road. A hydro-raking project to remove waterlilies and lotus in designated areas (see Figure 6 – Recommended Hydro-Raking Areas) would require approximately 60-80 hrs. of raking. A Hydro-Raking project of this size is expected to yield approximately 200-300 cubic yards of removed plant biomass, root systems and attached hydrosols. The disposal site of the

is available for decomposition, thereby reducing sedimentation rates and the potential for excessive internal nutrient recycling. It is our recommendation that the program begin with extensive Hydro-Raking to reclaim approximately 60% of the pond surface area as open water area, followed by area selective maintenance herbicide treatments, as required in subsequent years.

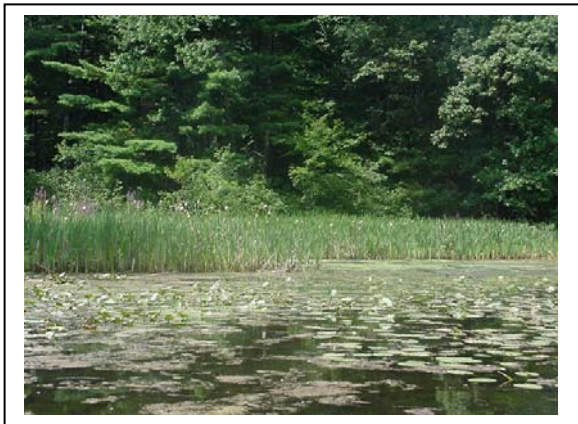
The inlet end of the pond contains a significant stand of cattails, with scattered growth of invading purple loosestrife. This area provides desirable nesting, and perching habitat for bird species such as Red-winged Blackbirds and other species that prefer freshwater marsh nest sites. Cattails also provide escape cover for a variety of mammalian species and are likely forage and den construction materials for Muskrats.

Photo 1 – Emergent cattail growth.

Hand-Pulling or hand-harvesting is an effective low-impact, non-chemical alternative to controlling a variety of unwanted vegetation species. Because hand-pulling is labor intensive on a large scale it best suited for very low plant densities. The purple loosestrife infestation at Fairyland Pond appears to be in the beginning stages and only consisted of a dozen or so plants at the southern end of the pond, at the time of the survey. We therefore feel that hand-pulling is an appropriate means of controlling and/or potentially eradicating this non-native plant from the resource area before it becomes too wide spread.

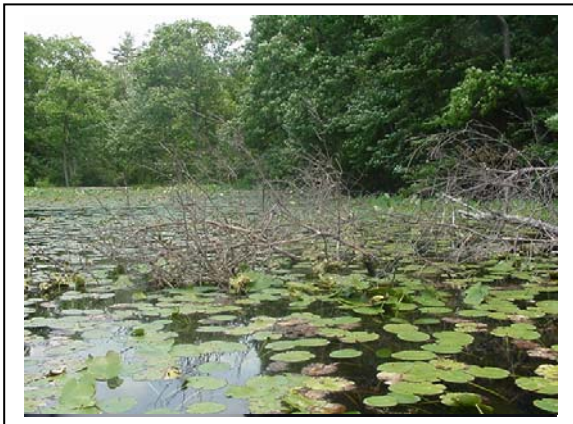
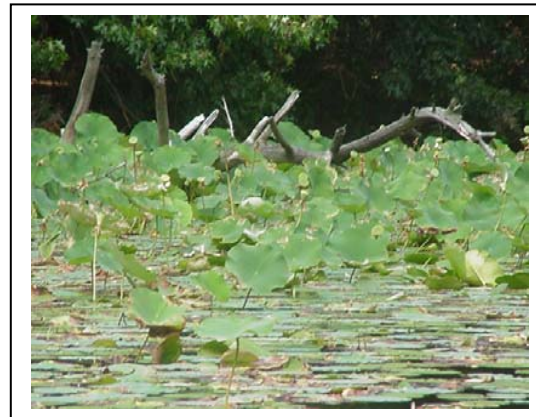
Deadfall trees submerged and emergent within the littoral zone provide a number of potential uses for resident wildlife. In fact, at the time of survey several Eastern Painted Turtles (*Chrysemys picta picta*) were observed basking along the trunk of the deadfall depicted in Photo 3. In addition to basking these trees provide perching sites for bird species like the Great Blue Heron and the Double-Crested Cormorant.

The submerged portion of the tree provides excellent underwater structure that is particularly important to warm-water fish species. These areas are typically utilized as ambush sites for predatory species like Largemouth Bass.

Photo 2 – Deadfall tree

Photo 3 – Deadfall tree

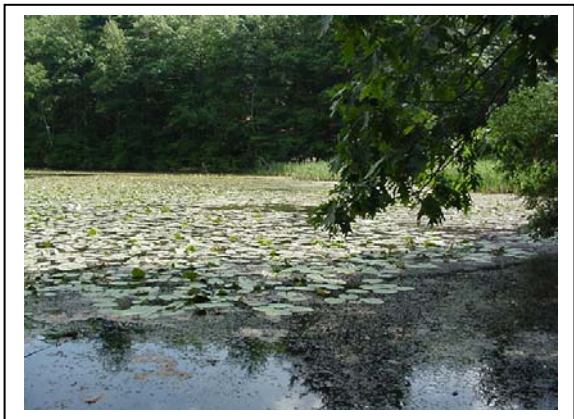
Overhanging vegetation provides perching sites for piscatory bird species like the Black-Crowned Night Heron, Belted Kingfisher, and/or Osprey. The overhanging vegetation also provides cover from predatory avian species to resident fish.

Photo 4 – Overhanging shoreline vegetation

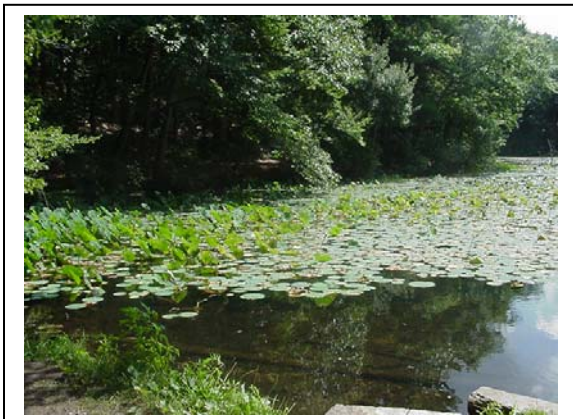
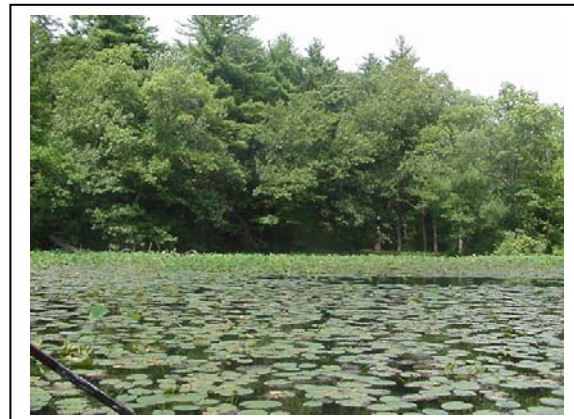
Edge habitat is particularly important to predator/prey interaction. The transition area between vegetated areas and open water (“Edge”) are important feeding areas for both wading bird species and predatory fish. In fact, a Great Blue Heron (*Ardea herodias*) was observed wading along the edge of vegetation depicted in Photo 5. The dense vegetation provides excellent escape cover and desirable juvenile fish nursery habitat.

Photo 5 – “Edge” habitat.

Photo 6 – Dense floating-leaf and submersed vegetation growth.
